CITY OF NORTHAMPTON – PUBLIC WATER SUPPLY

YEAR 1 IMPLEMENTATION OF FOREST STEWARDSHIP PLANS ON WATER SUPPLY PROPERTY

PHOTOGRAPH UPDATE – MARCH 10, 2014

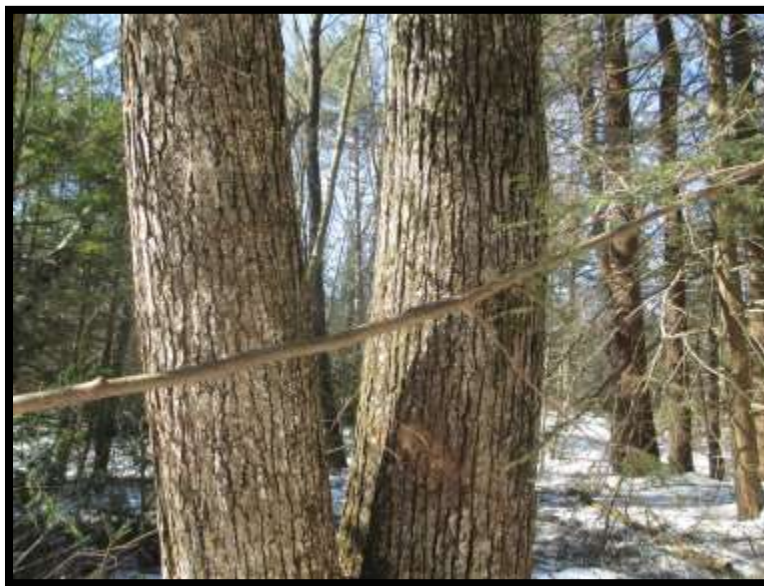
A pair of white oaks in the logging area. White oak is one of a number of native trees (e.g. sugar maple, black cherry, beech) that are not abundant in the logging area. Identifying and keeping these trees is an important step in preparing for forest management that seeks to maintain and increase biodiversity. One possible outcome of keeping these white oaks is that new white oaks will seed in to the nearby opening so that, over time, the less-common species become more abundant.

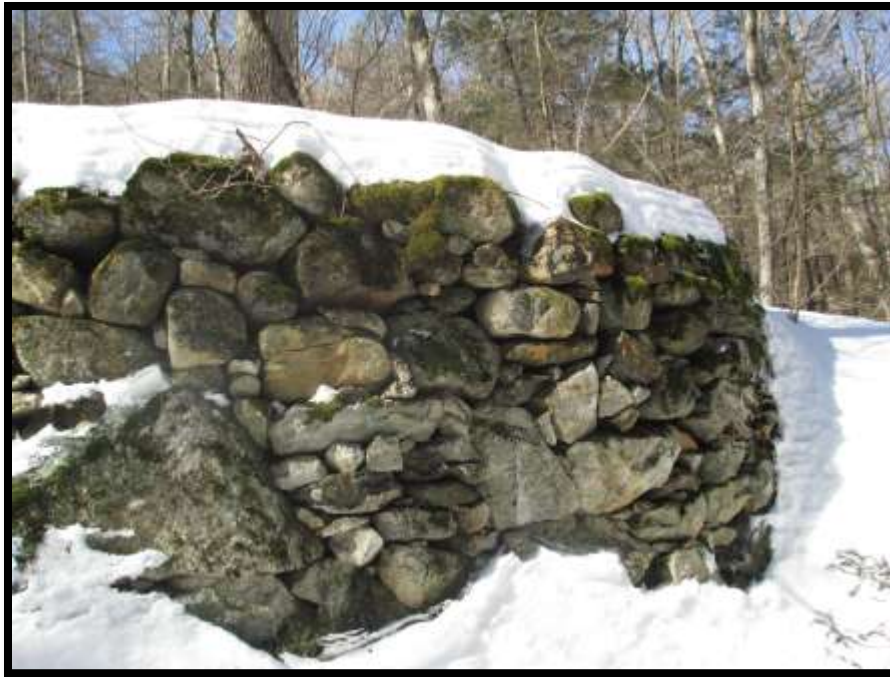
Part of the impressive stone foundations that belonged to a sawmill on Avery Brook. The sawmill site is about 1/2 mile upstream from the logging area. Avery Brook, or West brook, as it is sometimes still called, is said to have had seven major mill sites, or mill "privileges". This was the site furthest upstream. With the limited transportation capabilities at that time, most of the logs going into the mill would have come from the immediate vicinity, including possibly from the area of the winter 2014 logging.

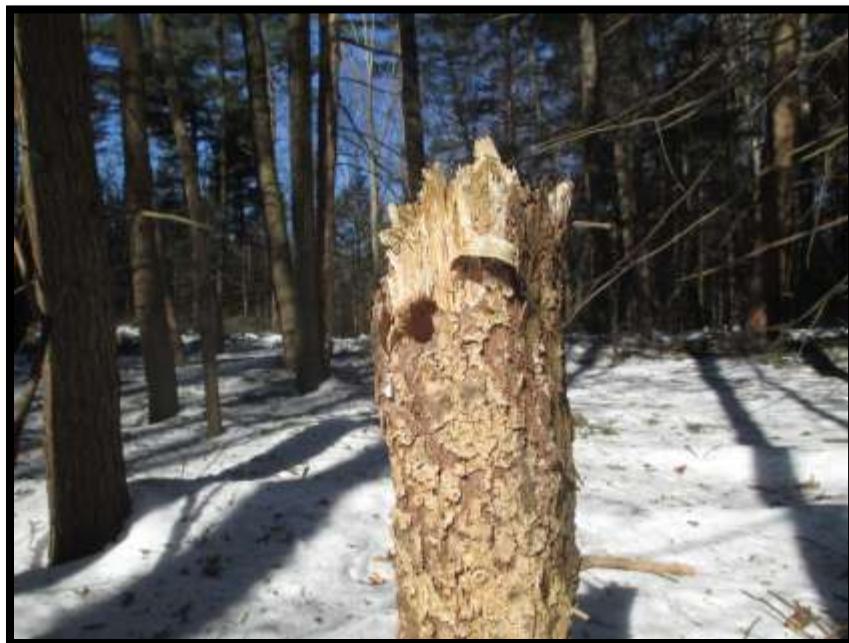
Remains of a hemlock that died in place and eventually broke off, leaving a stump. The rotten wood at the top of tall stumps is often used by chickadees, nuthatches and small woodpeckers, which peck out small nesting chambers.

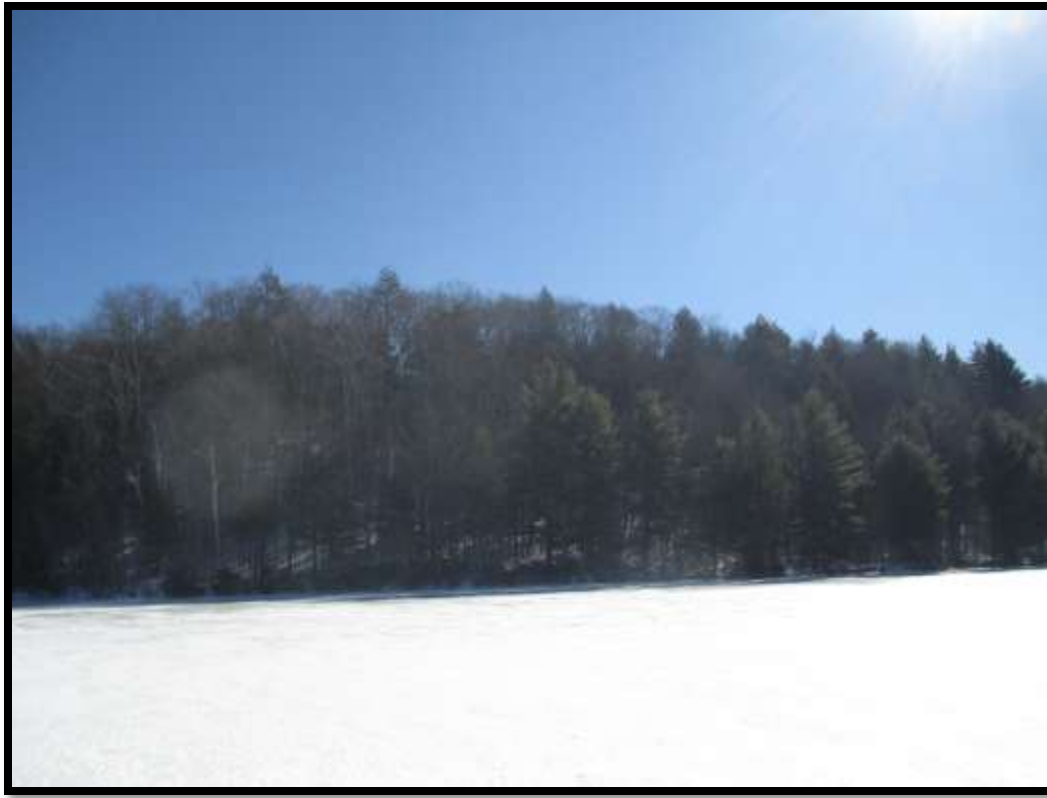
View of Stand 19 from the west, about two weeks after logging was complete in this area. The hillside features a mix of hardwoods such as red oak, black birch, paper birch, red maple, shadbush, and American beech, along with white pines. A few hemlocks remain at the top of the slope. The dark, low vegetation at the bottom of the slope is mountain laurel. On the left side of the slope (not visible in this photo) there is an old, narrow cart road that was hand-dug into the side of the slope, presumably in the late 1700's.

The steep sides of Stand 19 were not part of the recent logging. The City uses logging as a tool to shape the watershed forest. In many areas of the forest, the trees are crowded together, limiting each other's ability to grow freely and be vigorous. Also, there are few areas with young trees that are free to grow (i.e., there are few areas with young trees that are not shaded out by tall trees). Ideally, the watershed forest would be well-stocked with vigorous trees in a range of sizes and ages that are free to grow. Logging can help make this happen. Logging crews are brought in to cut trees that have been selected and marked with paint by the City's consulting forester. In some cases, the marking results in a thinning effect, giving nearby trees more room to grow. In other cases, the marking creates small openings in the forest that can fill in with new trees that grow naturally from native seed, re-sprouting, or from pre-existing seedlings. In other areas, no marking is done at all and the forest in that area is not cut. These "no cut" areas include land that is steep; wet or too remote; and areas with established populations of non-native invasive plants or native grape vines. These areas are "no cut" because it is felt that the anticipated benefits of logging (described above) would be outweighed by negative consequences (e.g. erosion, rutting of soil, or causing an increase in undesirable vegetation). The City's Forest Stewardship Plan, prepared in 2012, delineates in a broad way the areas that are suitable or not suitable for logging at this time. When the forester goes to mark areas that are considered suitable for logging (such as Stand 19), there is a further determination within that stand of areas that are or are not suitable for logging. Of 45 acres in Stand 19, logging was carried out on about 20 acres, and the remainder, such as these steep slopes leading down to the reservoir, was not logged.
